**CORROSION CONDITION SURVEY  
OF U1020 MONTANA AVENUE OVERPASS-BILLINGS  
FOR  
MONTANA DEPARTMENT OF TRANSPORTATION  
WJE No. 2000.2547  
November 27, 2000**

CORROSION CONDITION SURVEY  
OF U1020 MONTANA AVENUE OVERPASS-BILLINGS  
FOR  
MONTANA DEPARTMENT OF TRANSPORTATION  
WJE No. 2000.2547  
November 27, 2000

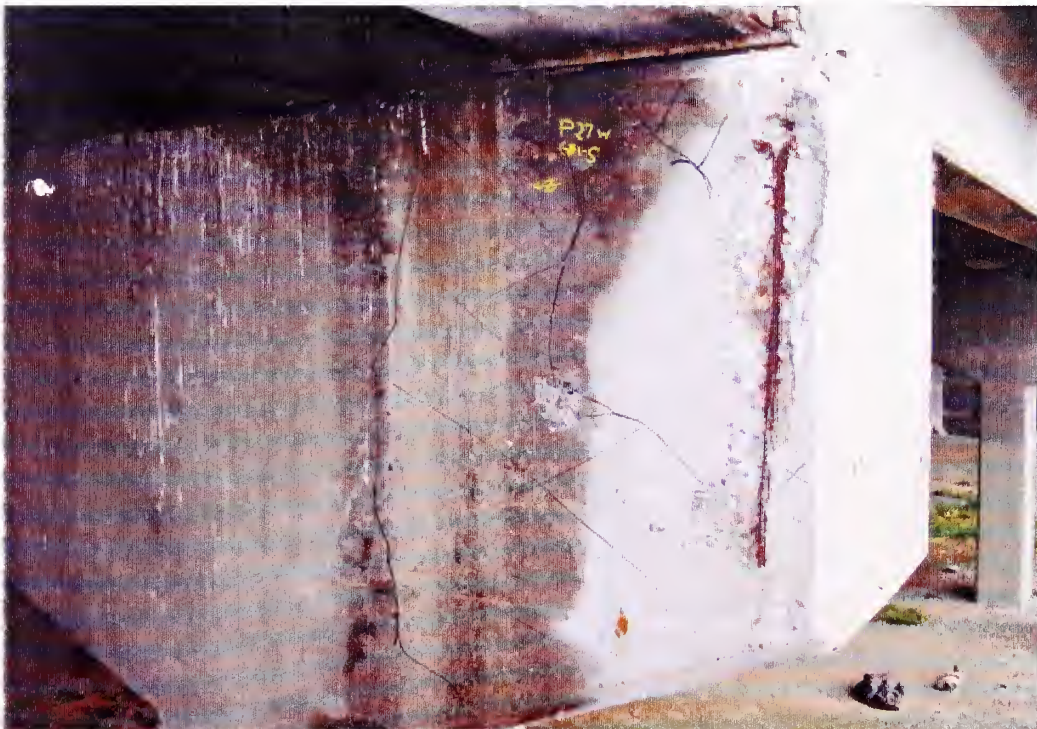
As indicated in Table 1 and Appendix A, many bent caps exhibit localized corrosion-induced damage, primarily in the form of discrete cracking and spalling. Figure 4 shows the west face of the eastbound Bent No. 27 with a spall exposing a corroded reinforcing bar and an adjacent delaminated area. Localized areas of some caps contained multiple fine cracks and pattern cracking which was not quantified. However, the locations of these minor distresses are schematically presented in the figures in Appendix A.

Figure 4. The eastbound Bent No. 27 cap showing a spall and delamination.

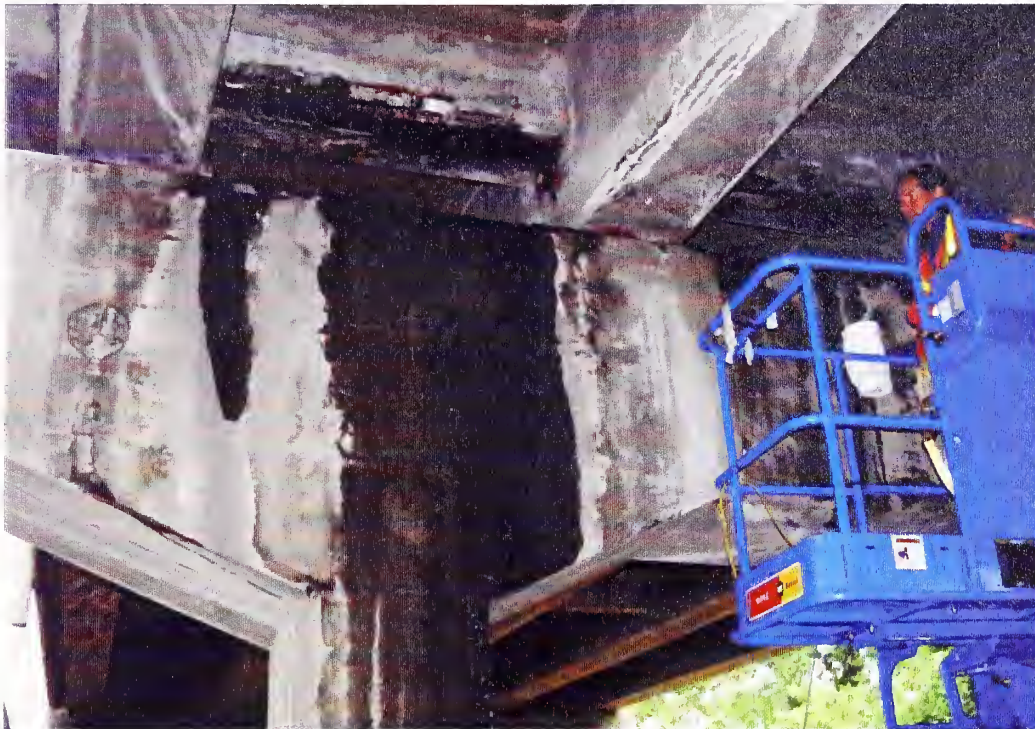
Many cap surfaces exhibited water stains, either dry or wet, due to past or current water leakage through deck joint seals. Figure 5 shows an active leak on the east cap face of the westbound structure Bent No. 29 at prestressed beams 4-5. Figure 6 shows the close-up view of the leaking joint shown in Figure 5. It shows a corrosion-induced spall and cracks on the cast-in-place concrete diaphragms between prestressed beams 4 and 5. The last column in Table 1 lists the actively leaking sections identified during the rainy field survey days. More comprehensive information regarding leakage can be found in Appendix A. The physical condition of these diaphragms is described in Appendix B.

Figure 5. Actively leaking westbound Bent No. 29 (east face).

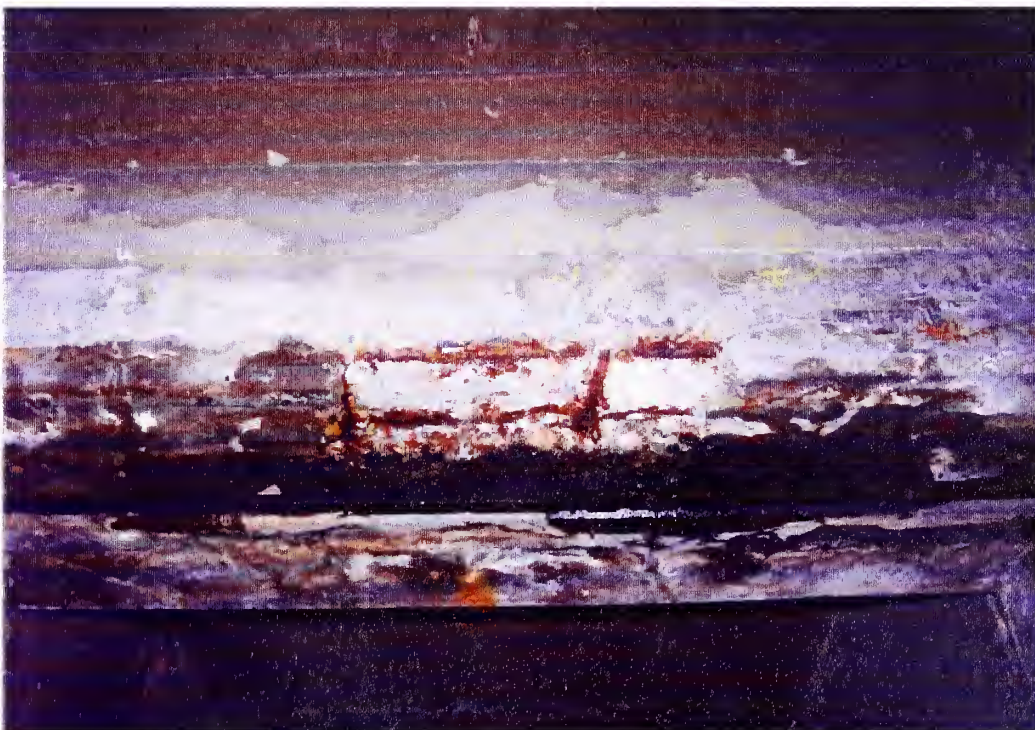
Figure 6. Close-up of the leaking joint shown in Figure 5.

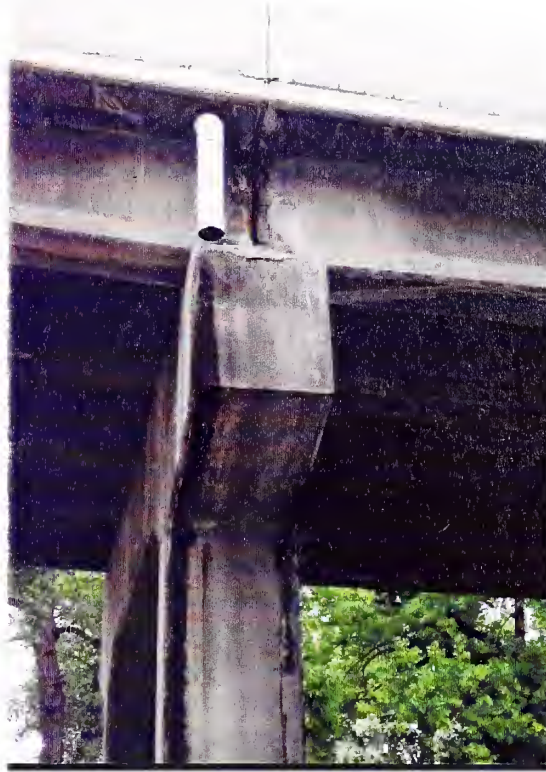
In at least one location, a contributing factor to cracking and corrosion-induced damage was the location of drainage pipes from the deck. Figure 8 shows an example of this situation observed during a rainy day. The water from the drainage pipe wetted the south cap end surface and traveled down along the edge of cap and column. A horizontal crack can be also seen near top of the cap end. When water contains deicing salts in winter seasons, it will introduce an even more corrosive environment than rainwater itself. When drainage pipes were located near columns or bents water discharged from the pipes was carried by the strong wind to wet the lower portion of the substructures, mainly columns.

Figure 8. A drainage pipe and a wetted cap and column.

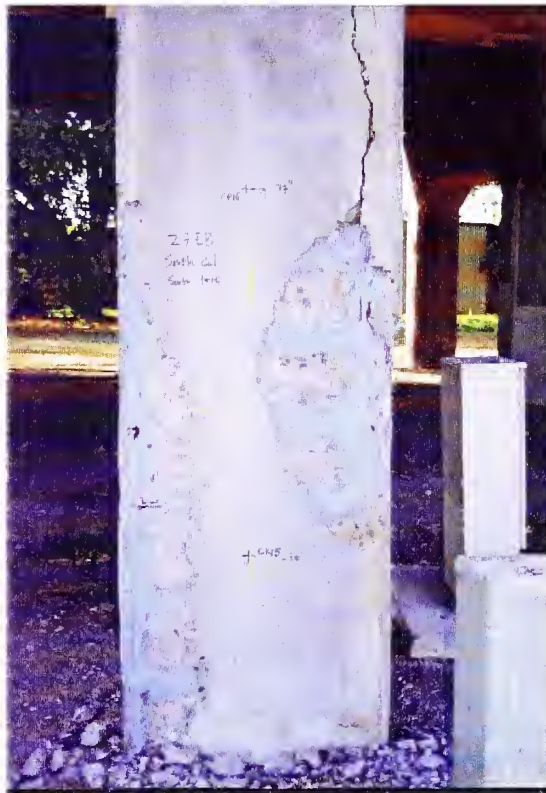
As Table 1 shows, a total of 85 cracks and 17 of spalls were observed on the eastbound and westbound columns. Figure 9 shows the typical spalling condition on the column having corroded reinforcing bars exposed. It was taken at the south face of the south column of the eastbound structure Bent No. 27. The spalled areas were commonly associated with large cracks and shallow depth of cover. The other types of distress include multiple cracks, pattern cracking and delaminations as summarized in Table 1. Actual locations of individual damage are schematically presented in Appendix A.

Figure 9. Deteriorated eastbound south column of Bent No. 27.

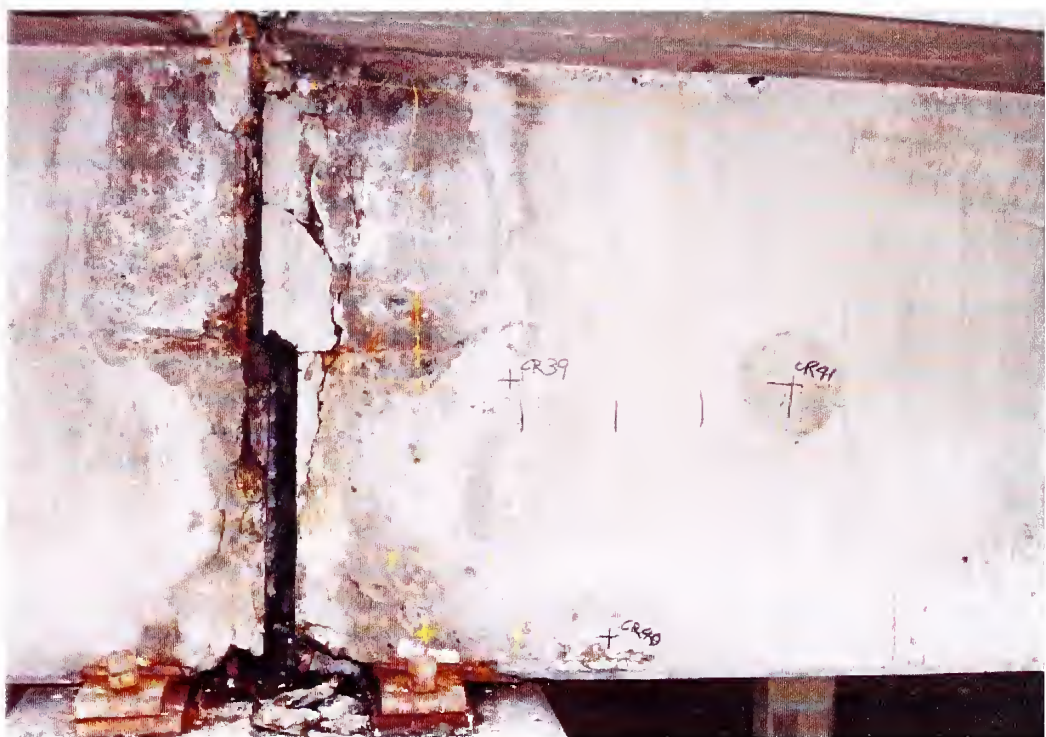
Figure 11. Prestressed beam No. 5 on Bent No. 25 of the eastbound bridge.

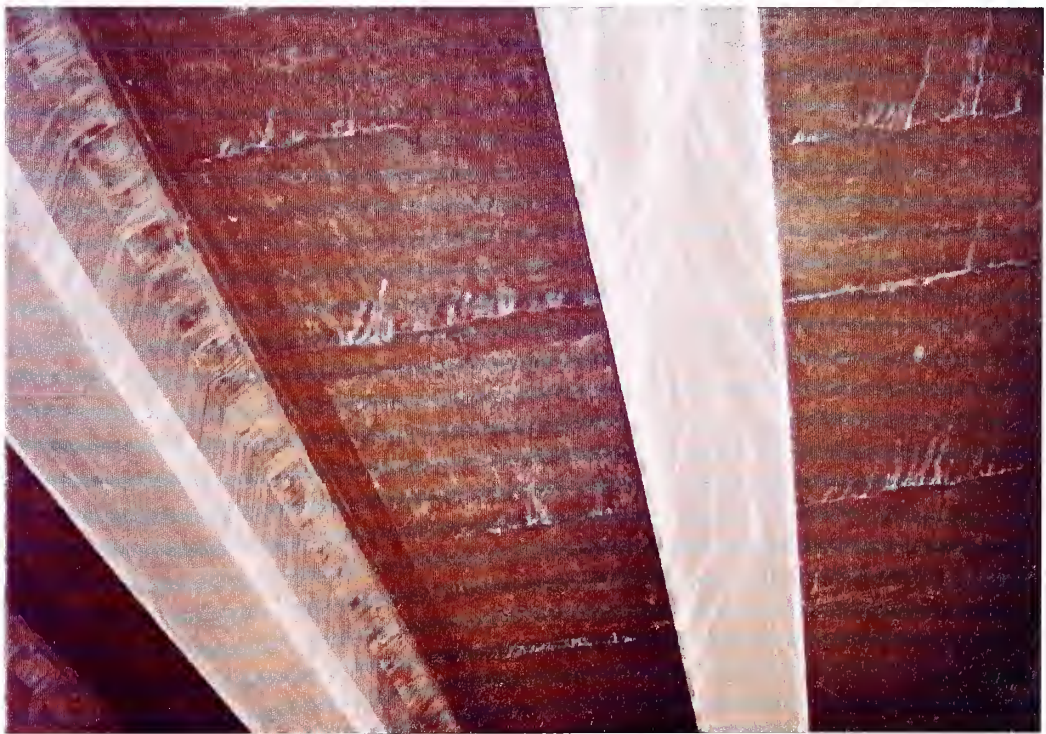
Figure 12. Typical condition of underside cracks.

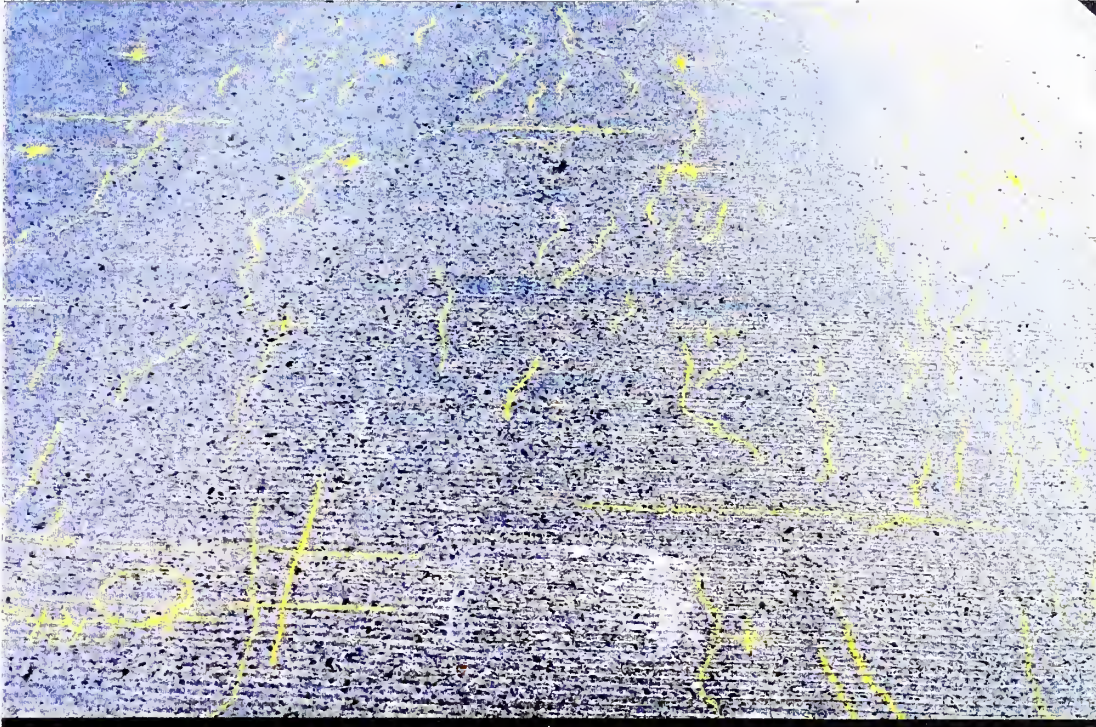
Figure 14. Condition of deck span 5 showing many cracks.

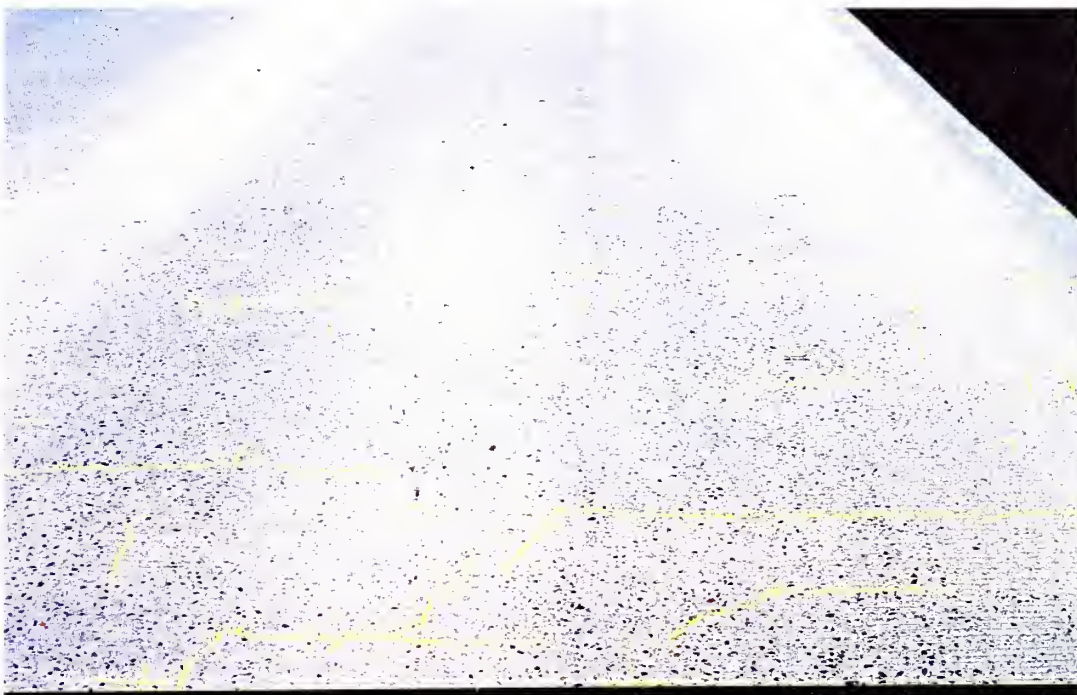
Figure 15. Similar condition shown in deck span 25.

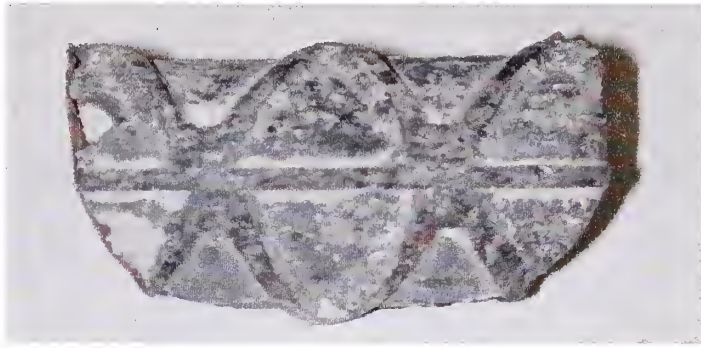
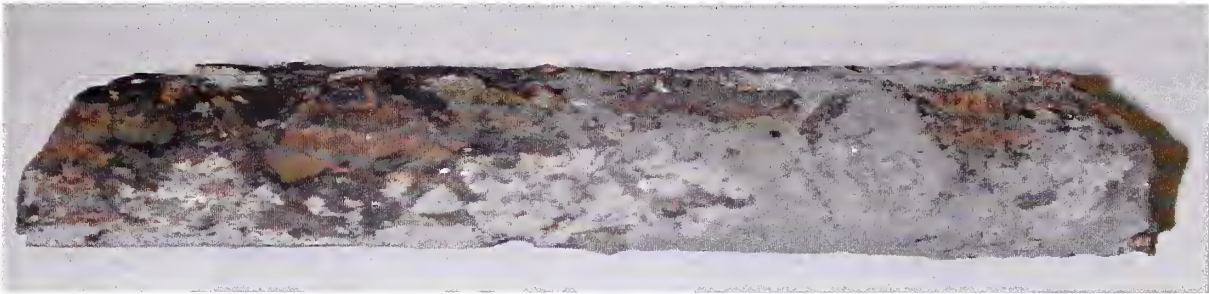
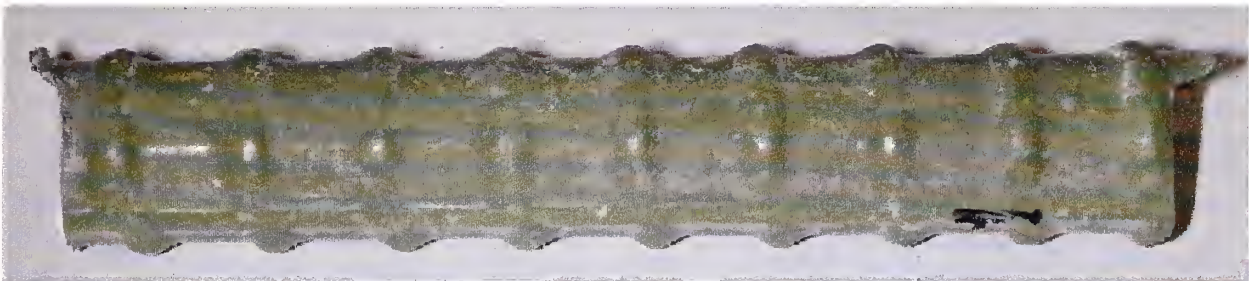
Table 3 describes the condition of the extracted bars and Figure 25 shows typical condition of three reinforcing bars with different degrees of corrosion.

(a) A #8 black reinforcing bar with mild corrosion (extracted from C23).

(b) A heavily corroded #5 black reinforcing bar (extracted from C12)

(c) A #5 epoxy-coated reinforcing bar in excellent condition (extracted from C3)

Figure 25. Typical conditions of extracted reinforcing bars.

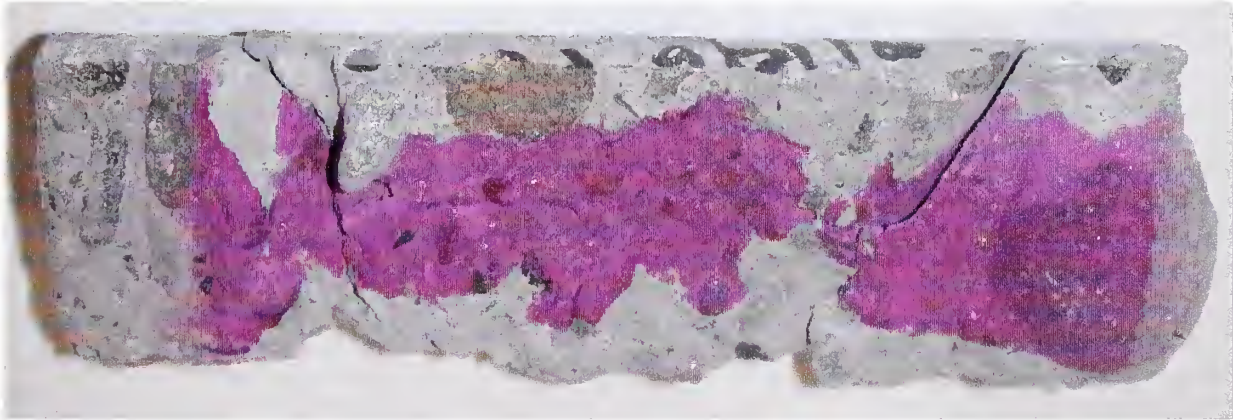
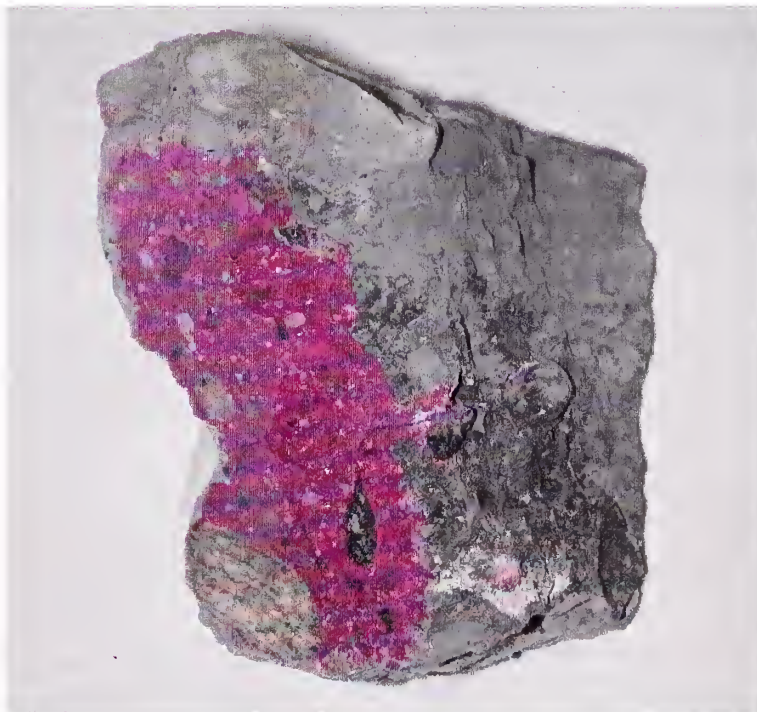
(a) Carbonated Core #30

(b) Carbonated Core #7 taken from a cracked deck location

Figure 26. Two examples of carbonation testing.

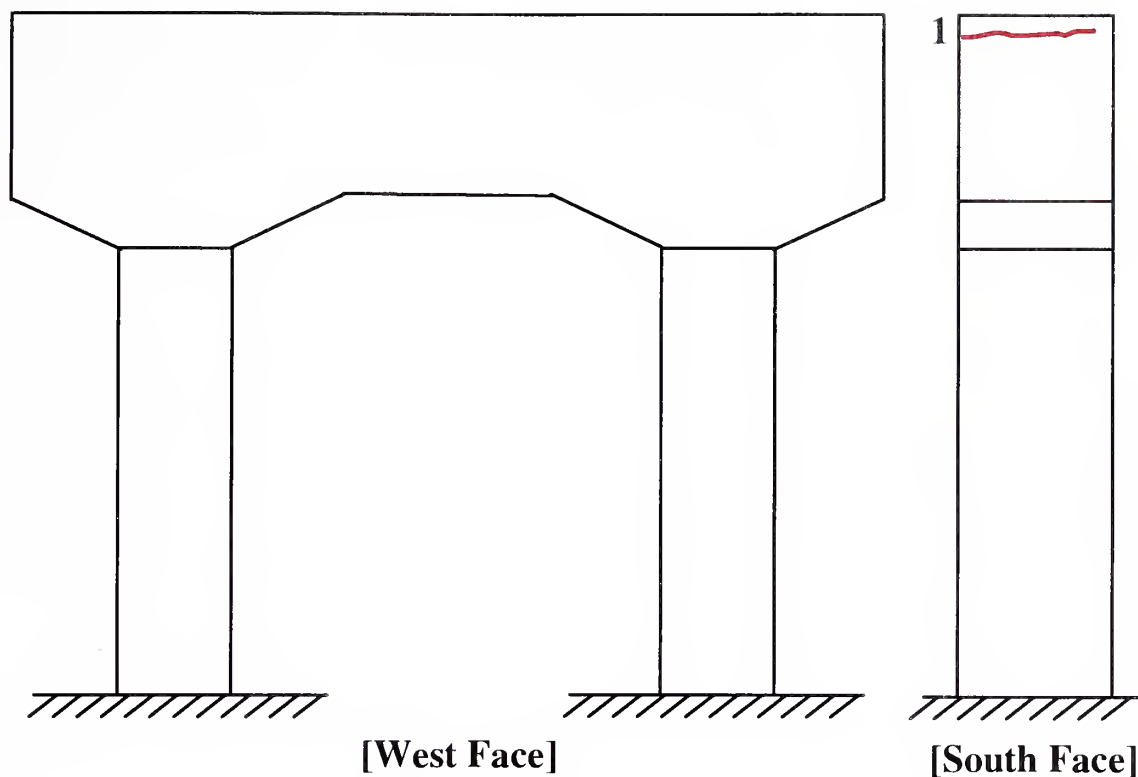
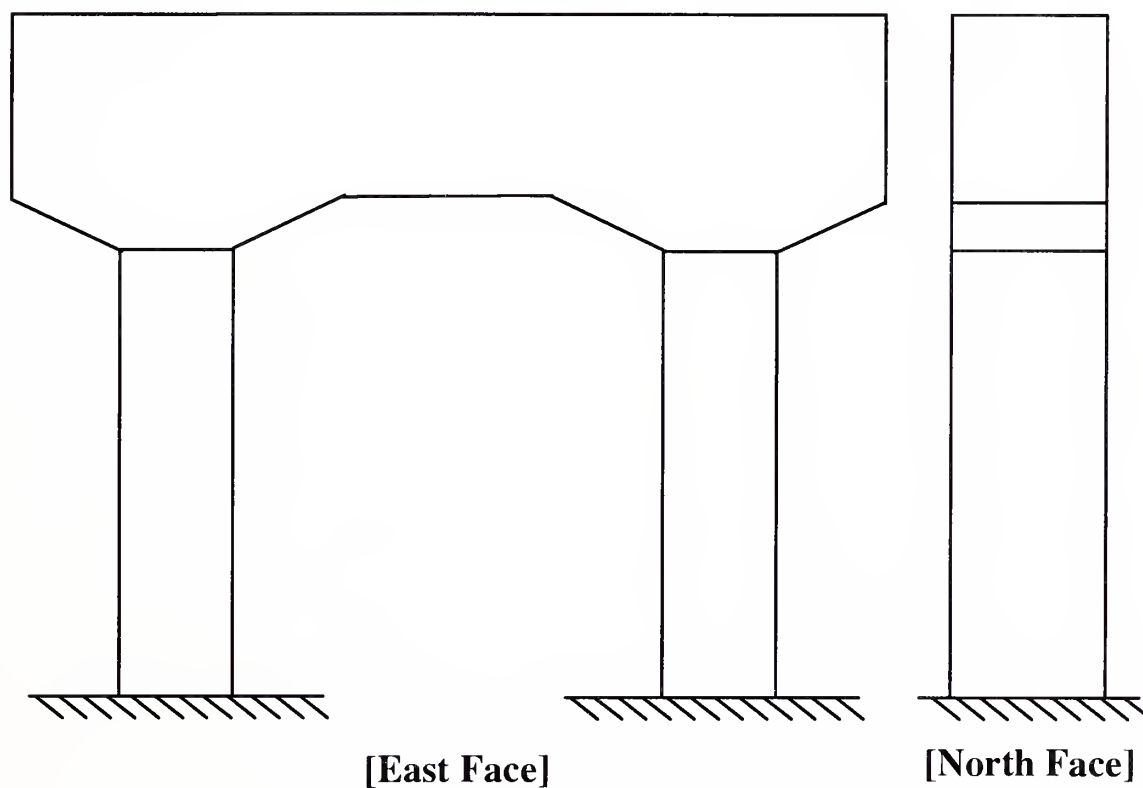
**Figure 1A. Condition of Bent No. 2 (East Bound).**

Damage	Location	Face	Description of Damage (No.)	Leakage Condition: No leakage
	Cap End	South	Crack (1)	
				Test Performed: None

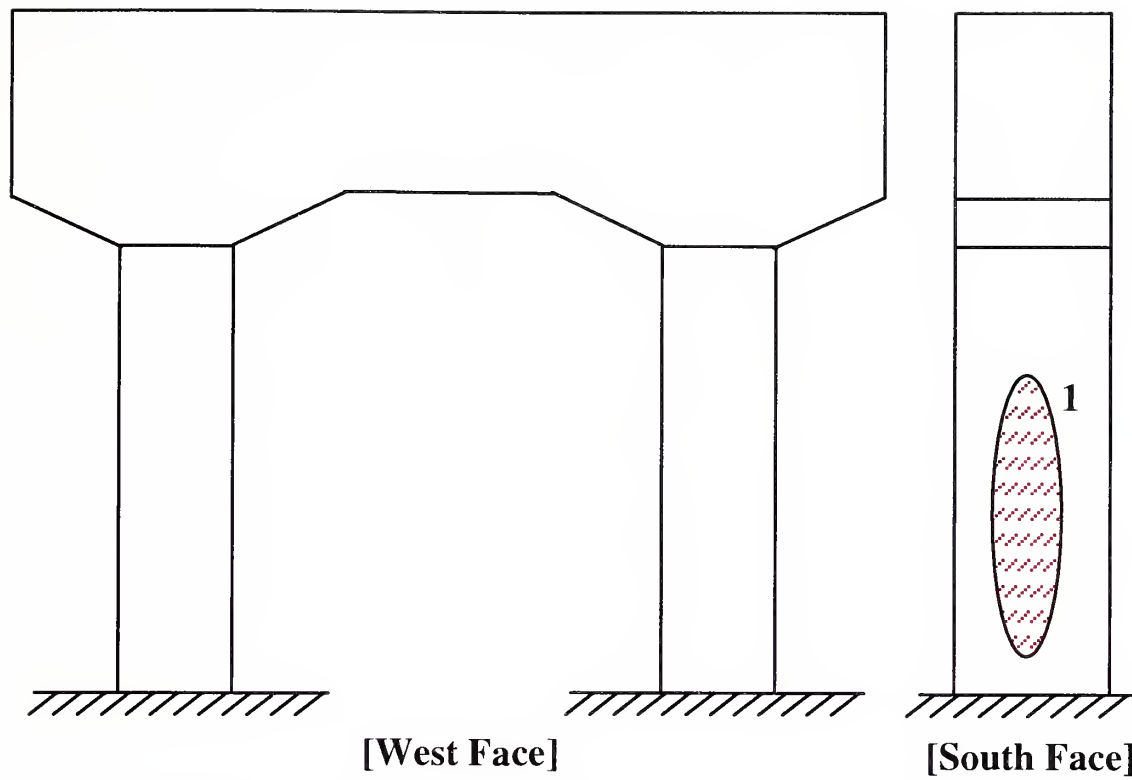
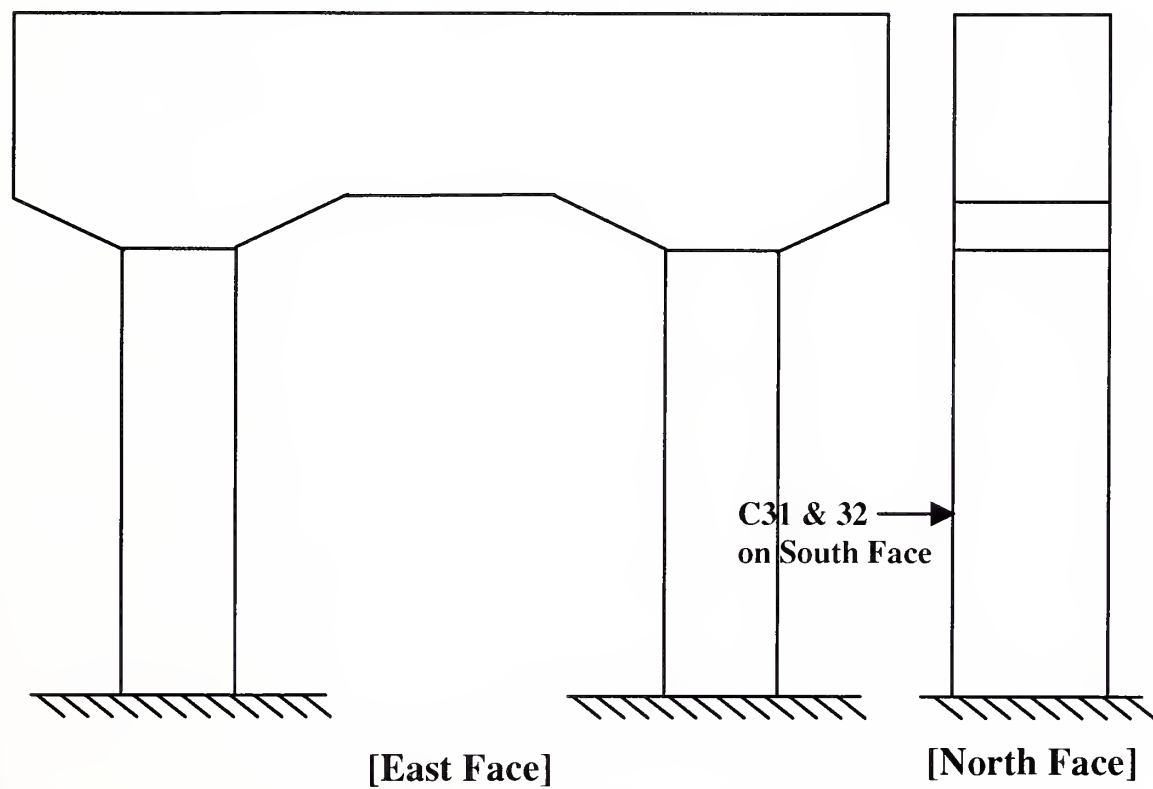
**Figure 7A. Condition of Bent No. 8 (East Bound).**

Damage	Location	Face	Description of Damage (No.)	Leakage Condition: No leakage
	S. Col.	South	Multiple cracks (1)	
				Test Performed: Cores 31-32

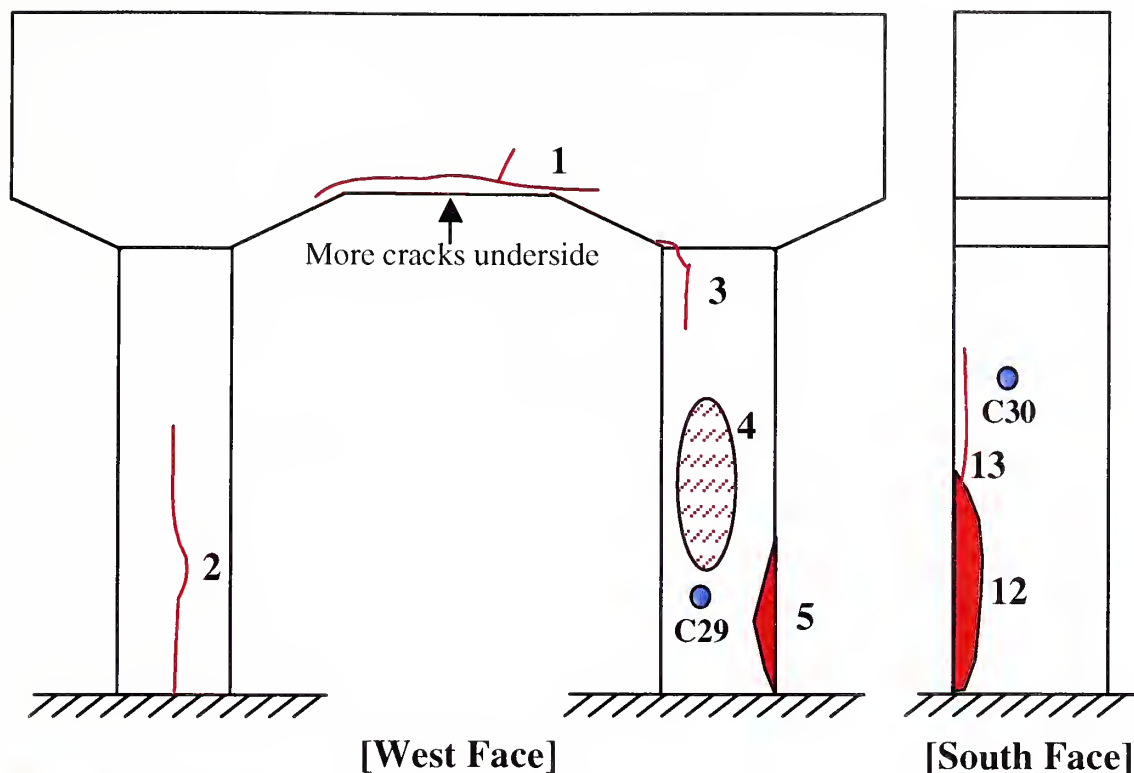
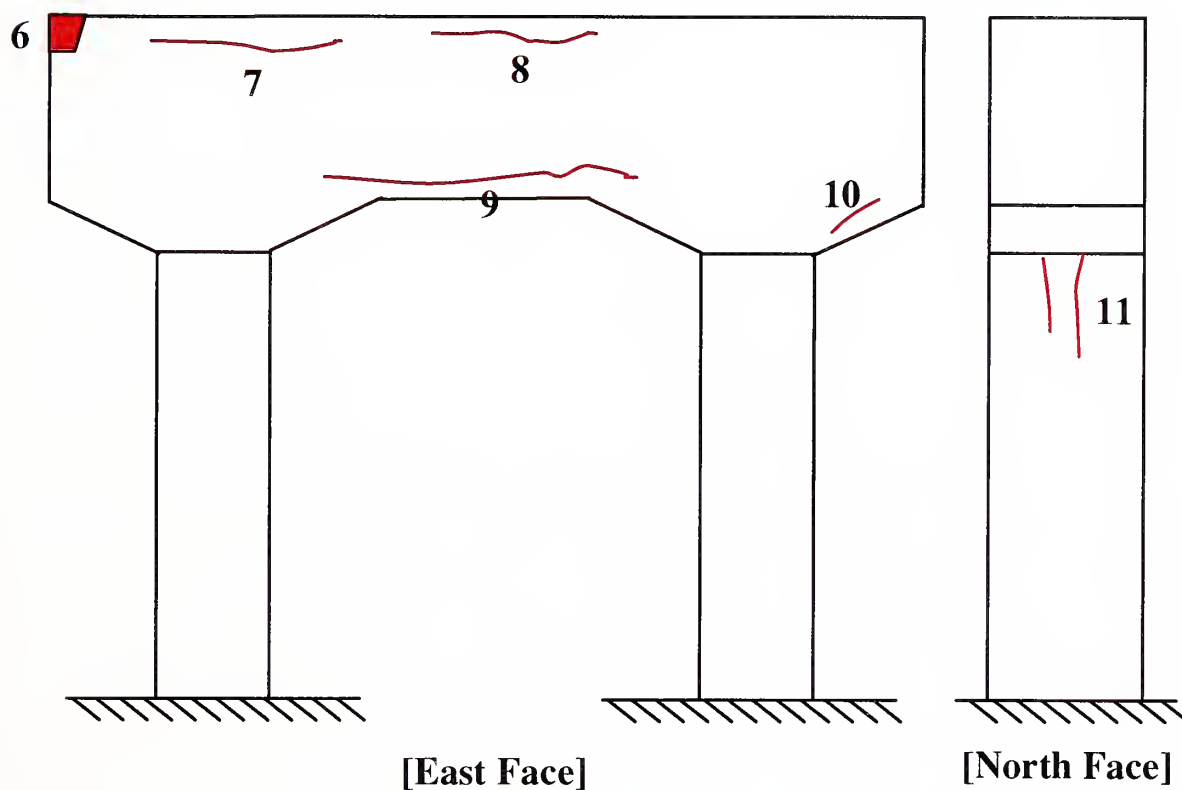
**Figure 8A.1. Condition of Bent No. 9 (East Bound) - To Be Continued.**

Damage	Location	Face	Description of Damage (No.)	Leakage Condition: No leakage but concrete exhibits dark stains  Test Performed: Core 29-30
	Cap	West	Multiple cracks (1)	
	S. Col.	West	A crack (2)	
	N. Col.	West	A crack (3)	
	N. Col.	West	Multiple cracks (4)	
	N. Col.	West	Spall (5)

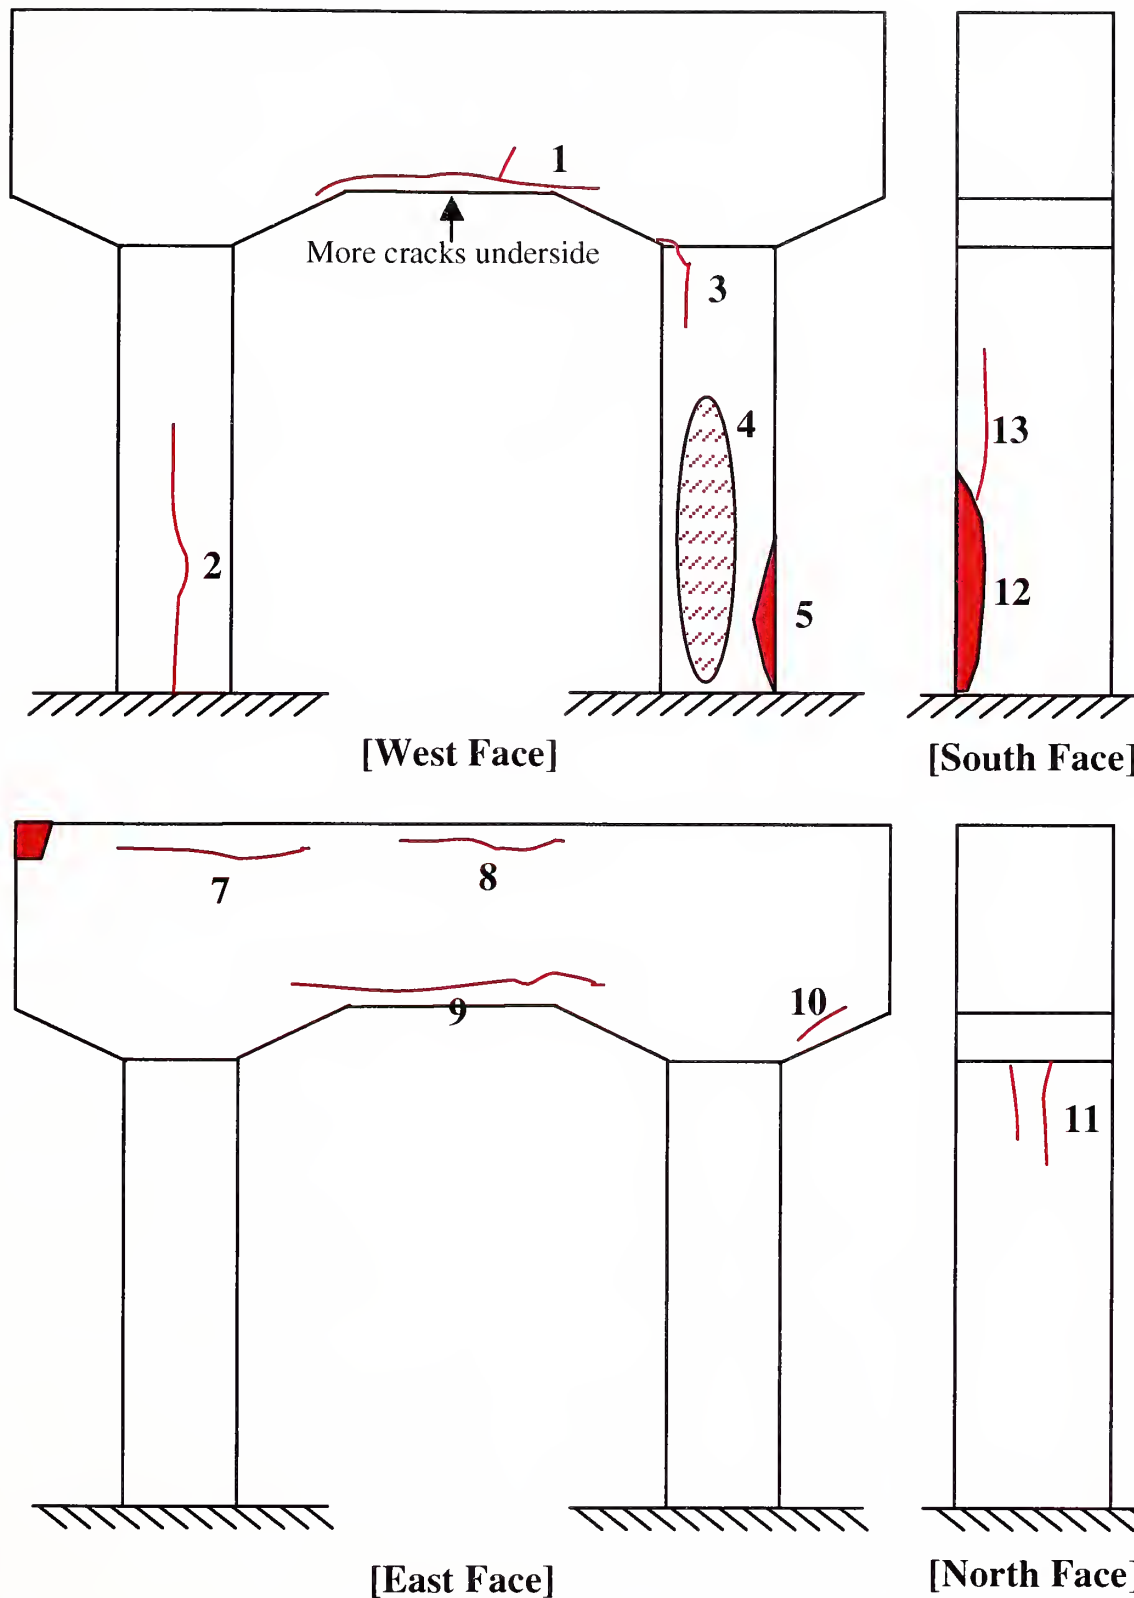
Figure 8A.2. Condition of Bent No. 9 (East Bound) - Continued.

Damage	Location	Face	Description of Damage (No.)	Leakage Condition: No leakage but concrete exhibits dark stains Test Performed: None
	Cap	East	Small spall (6)	
	Cap	East	Cracks (7-10)	
	N. Col.	North	Two crack (11)

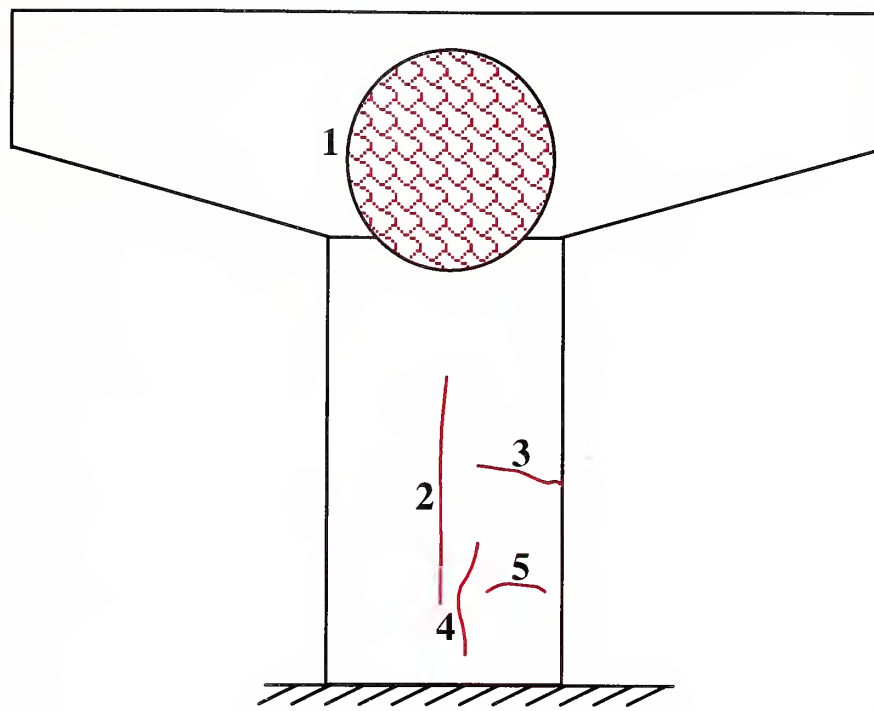
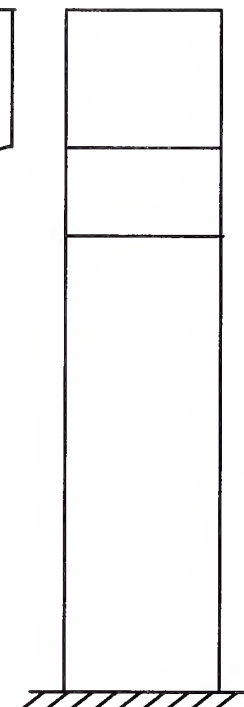
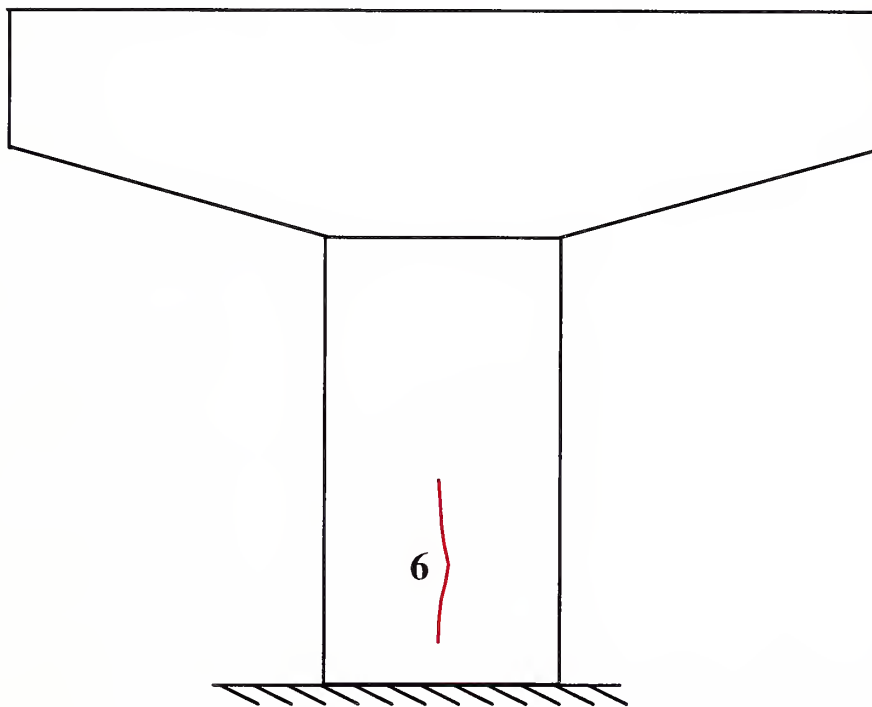
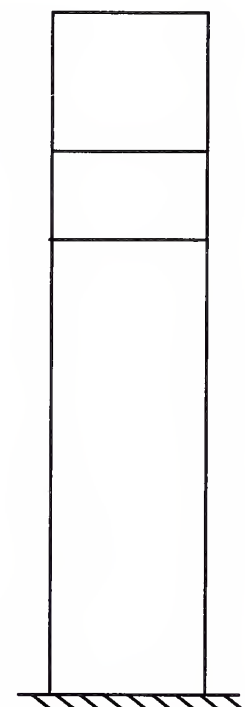
Figure 9A. Condition of Bent No. 10 (East Bound).

Damage	Location	Face	Description of Damage (No.)	Leakage Condition: Active leakage below beams 1-2, 2-3, 3-4
	Cap/Col.	West	Pattern cracking (1)	
	Column	West	Cracks (2-5)	
	Column	East	Cracks (6)	Test Performed: None

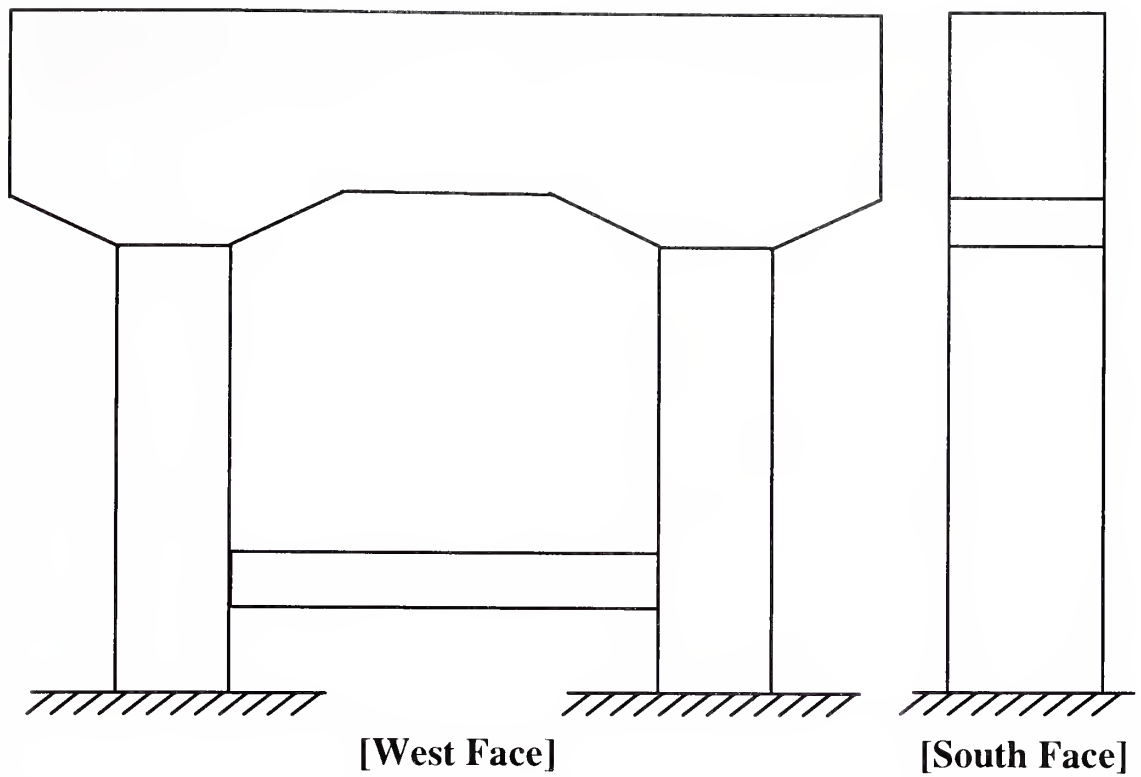
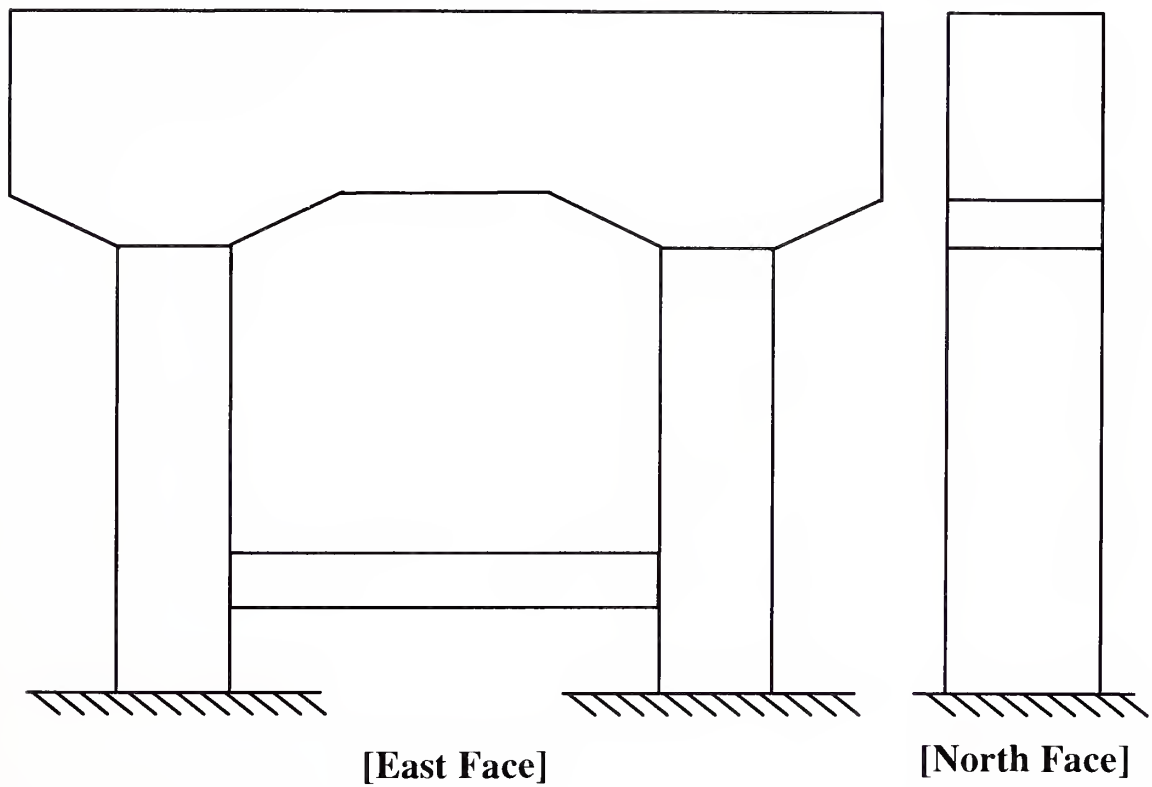
Figure 11A. Condition of Bent No. 12 (East Bound).

Damage	Location	Face	Description of Damage (No.)	Leakage Condition: No Leakage
		No Damage Observed		Test Performed: None

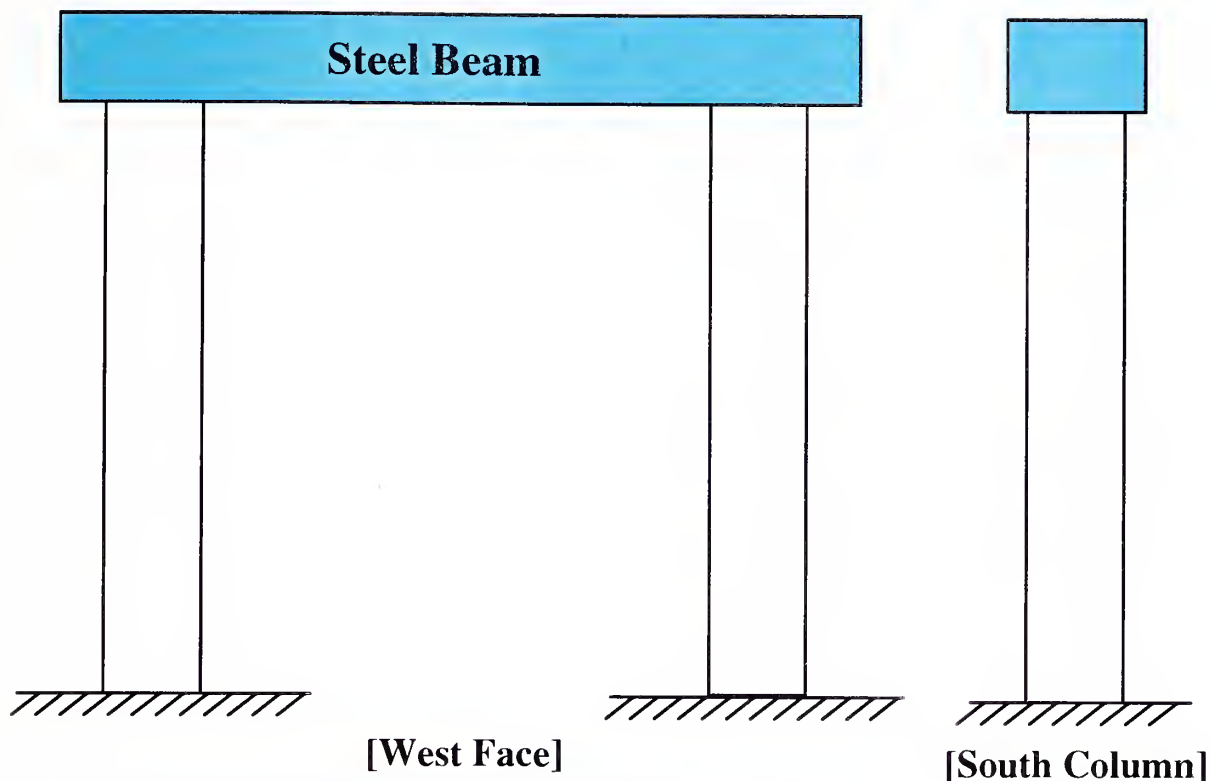
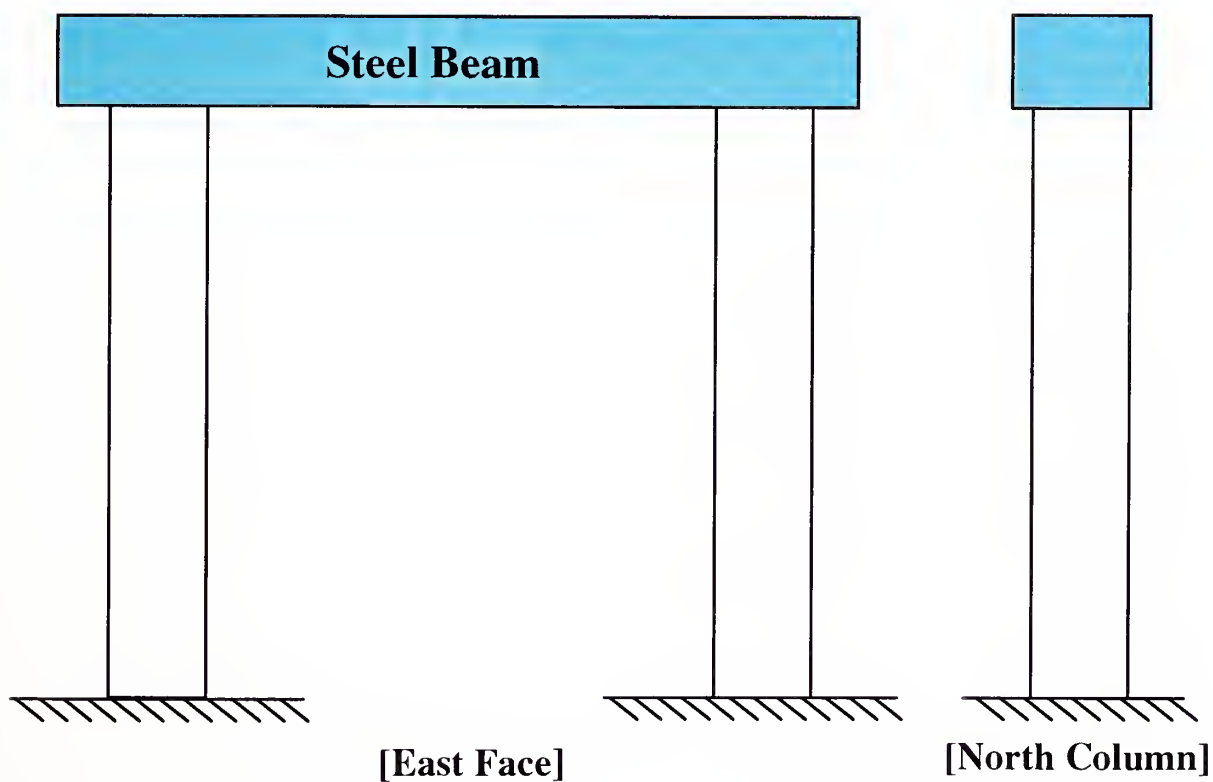
Figure 12A. Condition of Bent No. 13 (East Bound).

Damage	Location	Face	Description of Damage (No.)	Leakage Condition:
			<b>No apparent damage observed but pattern cracking on the entire surface of two columns (North column appeared to be worse than South one).</b>	No deck above and exposed
				Test Performed: None
